Anatomy of a **Restoration**

Recently, RM Auto Restoration completed one such restoration — a 1933 Duesenberg Model SJ Beverly, chassis SJ512, that was beautiful when owners Judge Joseph Cassini III and Margie Cassini purchased it but not entirely correct. The following before and after pictures show an informative glimpse into the subtle art of creating automotive perfection.

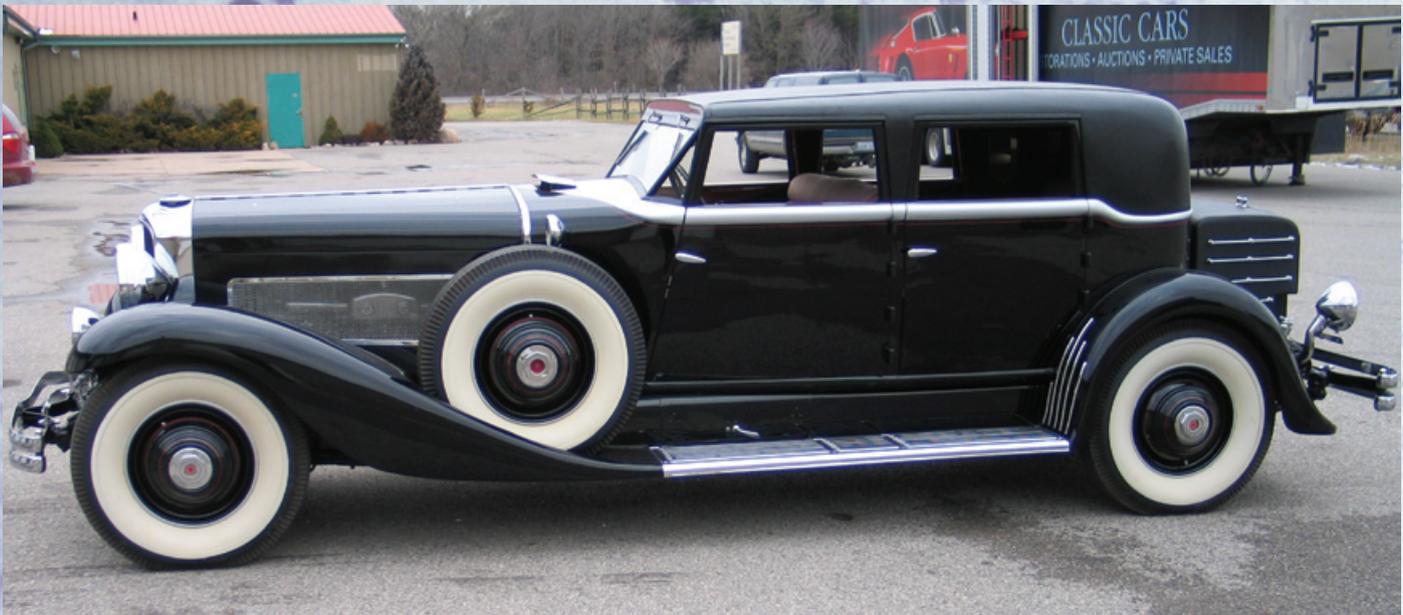
Shown here prior to the restoration, the only obvious incorrect features on SJ512 are the fenders, wheels and interior.

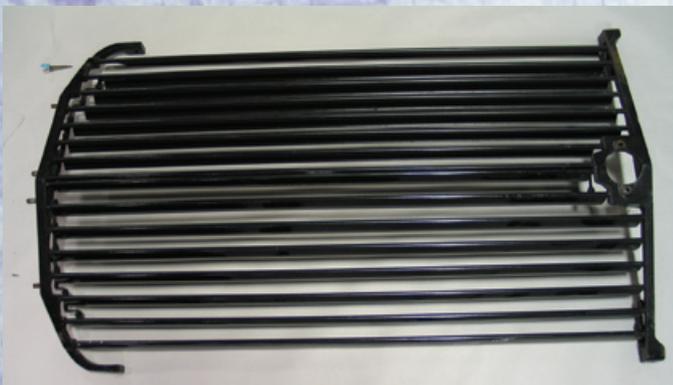
Seen here, the weather-front (radiator shutters) was incorrectly finished, as it was painted instead of chromed.

The iconic Duesenberg front end now shows the radiator shutters correctly chromed post-restoration.

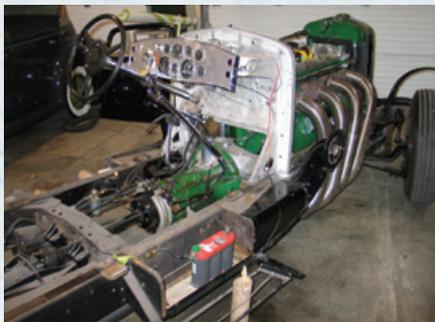
Careful inspection showed that the drivetrain was complete, pictured here during disassembly, and every component was rebuilt and refurbished.

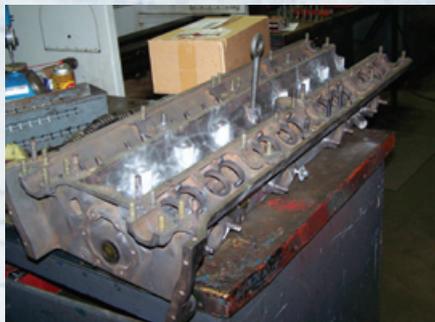
The disassembled Duesenberg Model J cylinder head with four valves per cylinder and dual overhead camshafts. This was the design responsible for the record-breaking, 265 hp output in standard form, 320 hp in supercharged form as found in SJ512.

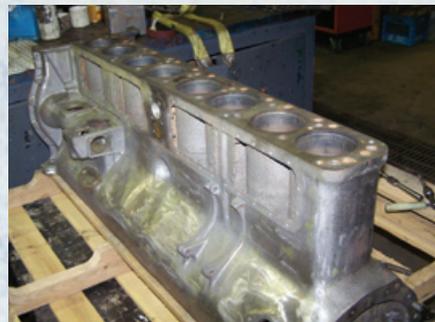
The Duesenberg Model J cylinder block, with its long stroke design and 420-cubic inch displacement, was found to be in excellent condition and only needing minor machine work, new pistons and babbited bearings.

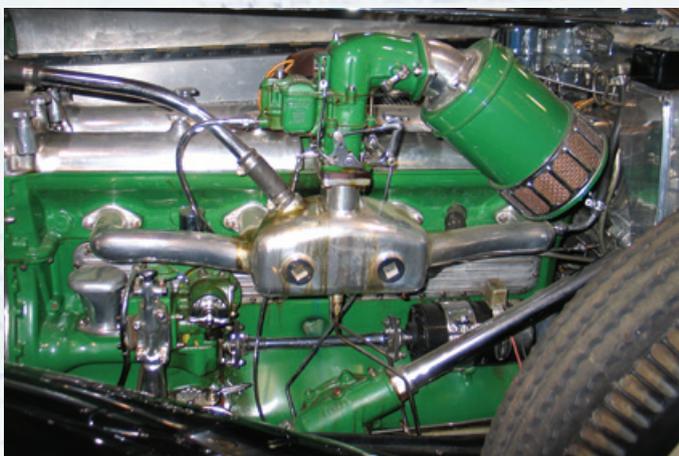
Seen here, the engine is in its naturally aspirated form, with a standard downdraught carburetor. SJ512 originally came with a Duesenberg centrifugal supercharger that had been removed many years ago.

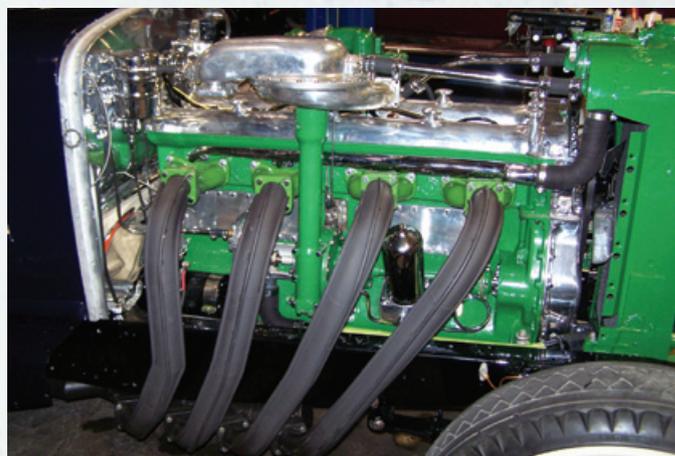
SJ512 fully re-built with its original blower in the test-running stage. The four chromed exhaust covers have not been fitted yet. At this point, many miles are put on the car, both on the road and on our chassis dynamometer to test for leaks, vibrations and to maximize drivability.

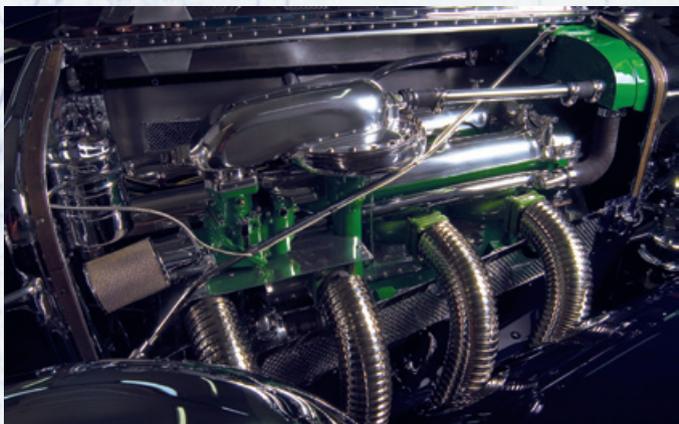
The blower-side of the engine polished and ready for its debut at Pebble Beach 2008.

Now complete and reunited with its original supercharger, which was purchased at auction by a previous owner of SJ512 for nearly \$300,000!

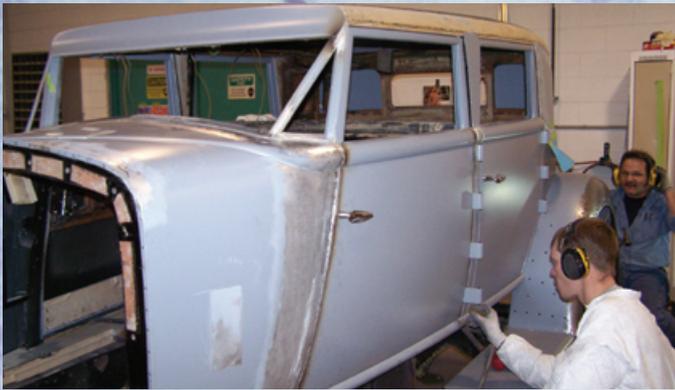
Hundreds of hours were devoted by RM Auto Restoration artisans to careful metal-finishing (pictured here), in addition to block-sanding, to prepare the surfaces for painting. Careful attention is paid to panel gaps and alignment.

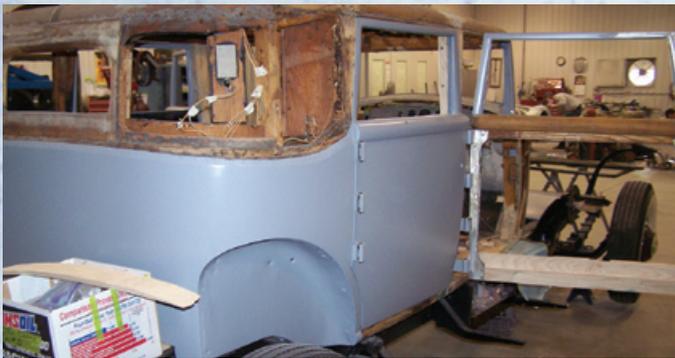
The body has been stripped to bare metal and epoxy-primed, giving it superior protection from the elements. Here the front door-skin has been removed to repair the wood structure that was weak on the bottom. As originally specified, seasoned ash is used to replace any rotted wood.

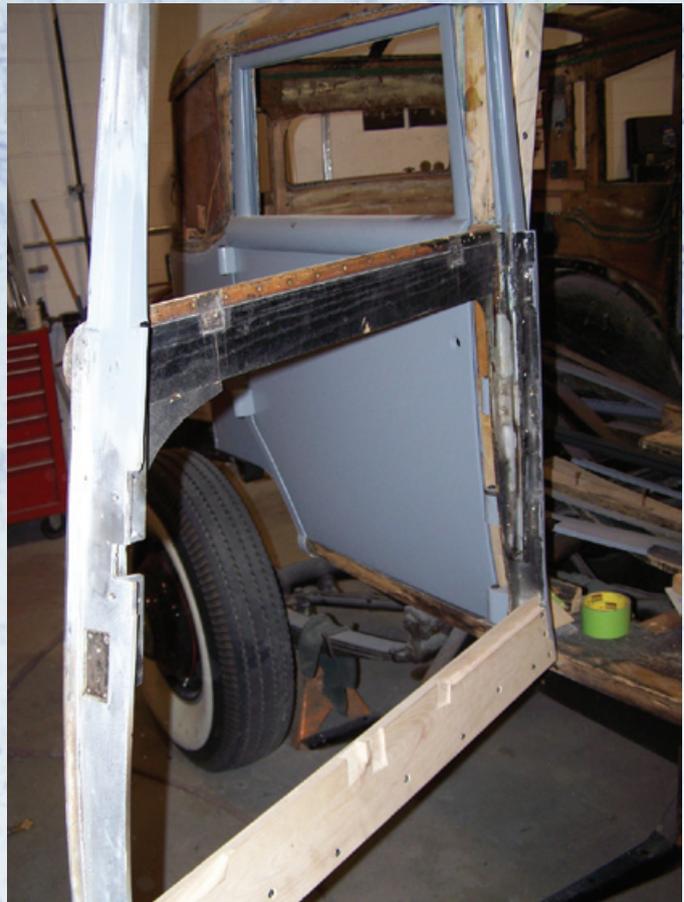
An example of the minimal wood replacement necessary, seen here with the aluminum door-skin removed. Also shown here is the exclusive Murphy coachwork feature of cast-aluminum door jambs, which creates a very stiff and long lasting structure. This would have been very expensive to build at the time, a process reserved for only the best hand-built cars.

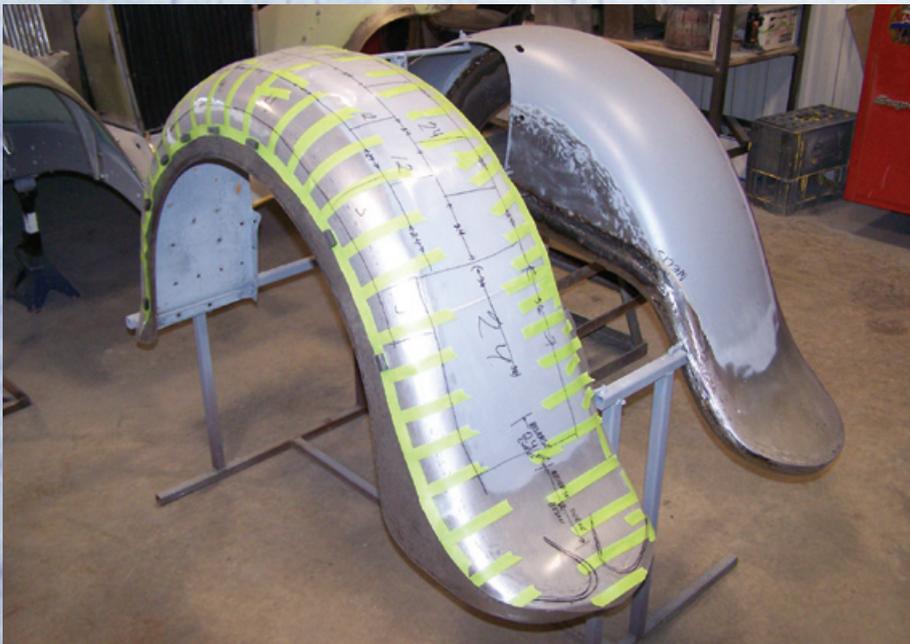
In the late 1930s, the SJ512 was taken back to a body shop to have the fenders modernized with a lower skirted profile. Here we can see patterns taken to bring them back to the original configuration as delivered new by the coachbuilder.

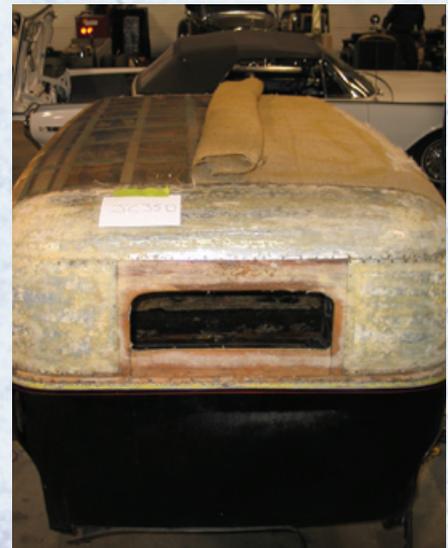
The roof was stripped to the many wood slats, which were removed and re-glued, while the rear aluminum curved panels were stripped and metal-finished. The complete roof was then ready for the new dark blue padded leather top.

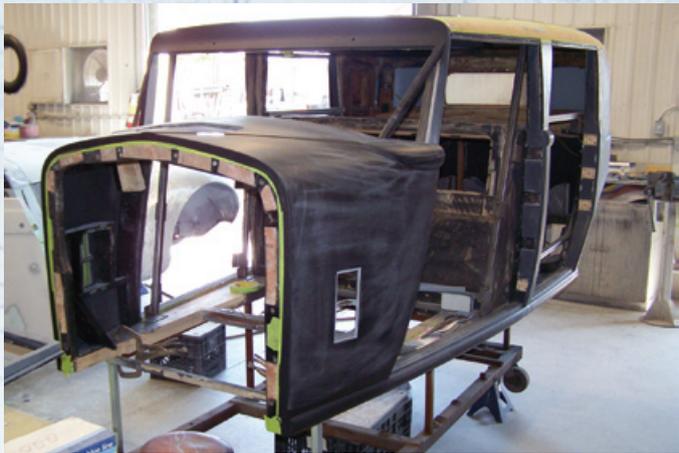
The car retained all its original bodywork, shown here in the final stages of priming and sanding. Primer is water-sanded to prepare the ultra-smooth surface needed for painting.

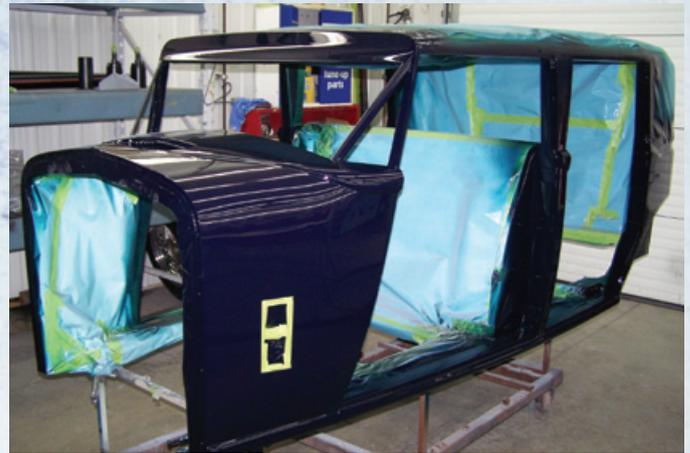
The paint was applied and baked to cure, then color-sanded and machine-polished to a concours-level finish.

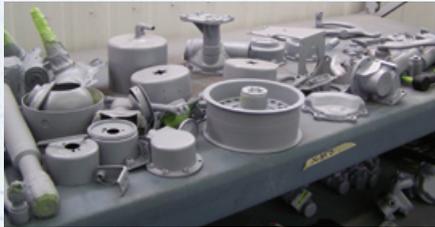
Here, disassembled drivetrain and chassis components that have been re-built are prepped and ready for painting.

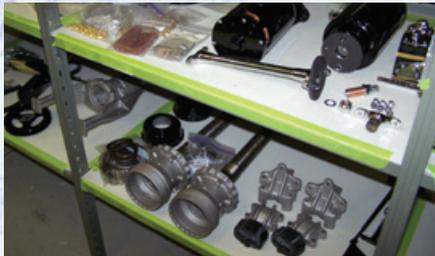
More drivetrain and chassis components disassembled, re-finished and ready to be installed on the chassis. The generator and starter have been rewound and fully rebuilt.

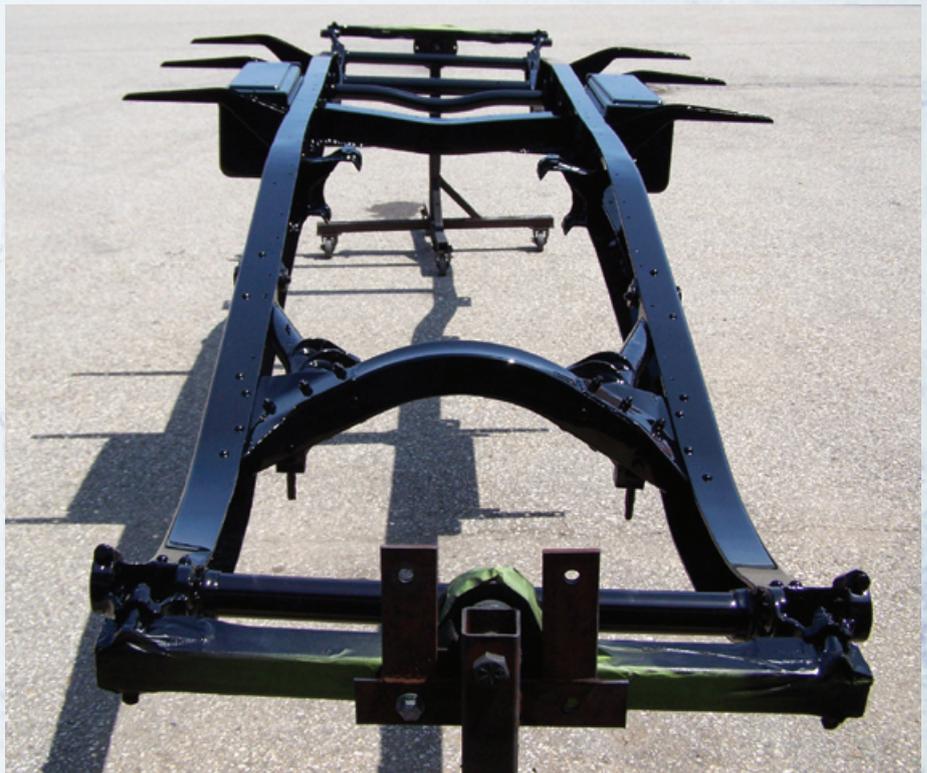
The mighty J chassis, shown restored with its new black finish.

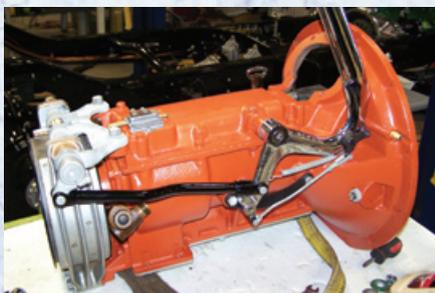
The 3-speed transmission with hand brake finished and ready to re-install. It had previously been completely disassembled and rebuilt with new bearings.

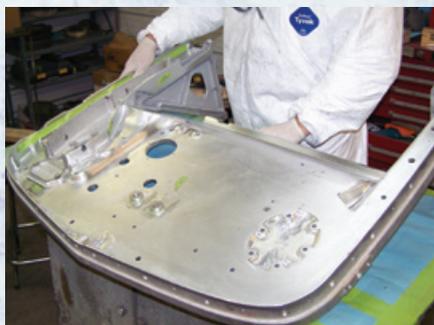
Here, our polishing department is preparing SJ512's firewall for polish. This was done in the exact same manner as it was done in 1933.

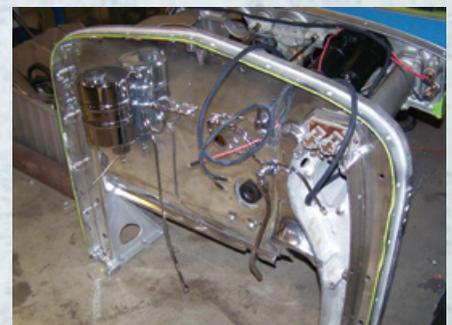
The monumental cast-aluminum firewall and instrument panel assembly is shown here re-polished and newly fitted with wiring and lines.

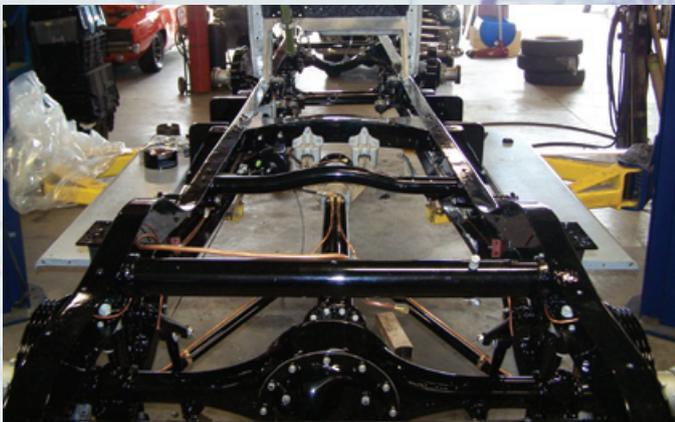
SJ512's chassis in the assembly bay with new brake lines and chassis lubricator lines installed. The cast-aluminum firewall and instrument panel has also been fitted.

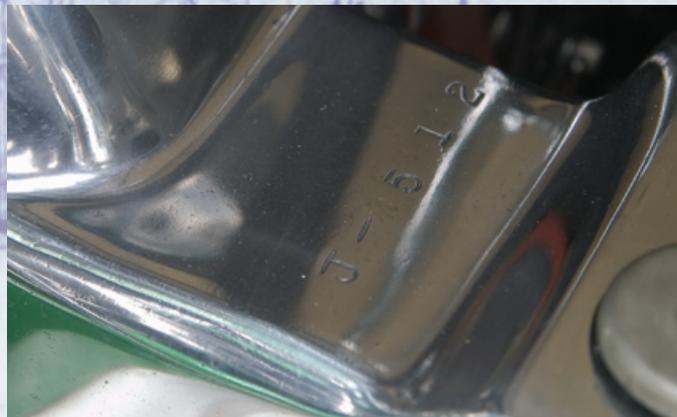
This is a photo of the cast aluminum bell housing that carries the all-important "J number" that all Duesenbergs are known by – J512 (S was understood to be added when the cars were supercharged).

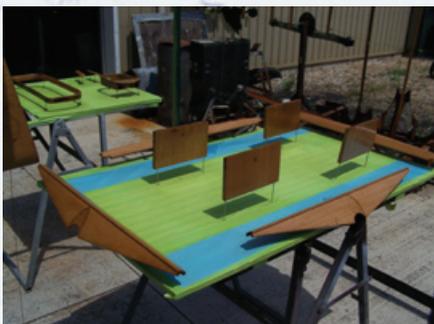
SJ512's original oak interior trim was in excellent shape and was all saved, only requiring stripping, refinishing and minor repairs. Note the subtle and original dual-tone finish on the oak.

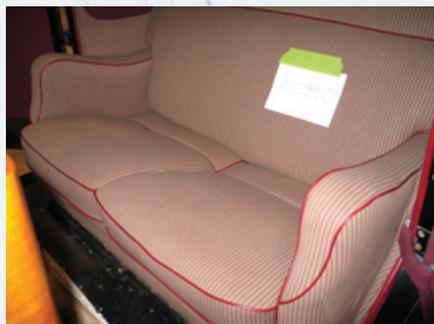
The interior, while attractive, was not as it would have been as when SJ512 was purchased new. The seats are the correct components but the fabric choices were not.

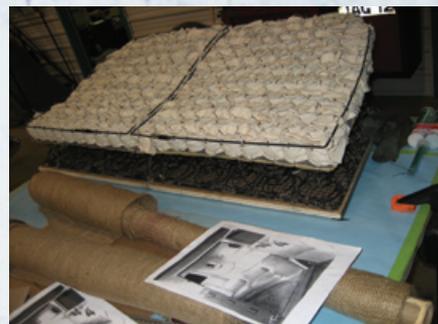
Restoration experts worked from Murphy's original studio photography of the car's interior when new to ensure their handiwork was entirely correct, as seen here during the construction of a seat.

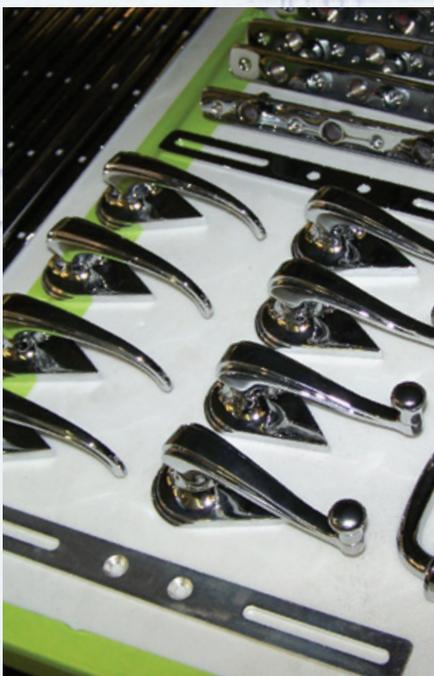
Distinctive Art Deco interior fittings by Murphy, fully restored and ready to install.

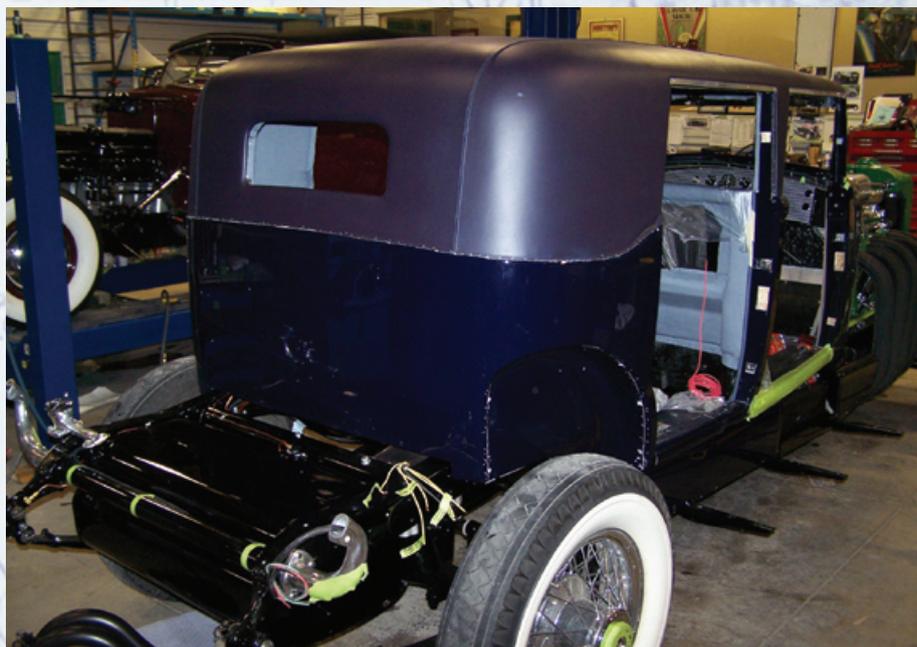
As the finished product comes together, easily scratched freshly painted or chromed components are covered in protective tape to prevent damage from the subsequent work. Here can be seen the new leather roof installed and fitted, waiting for edge trim.

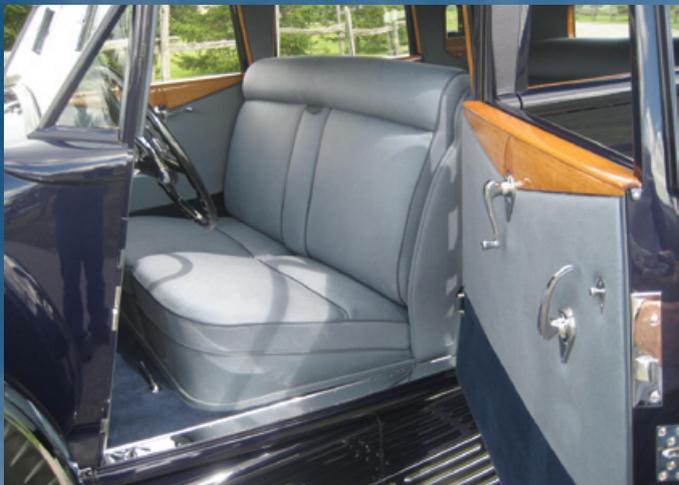
SJ512 now shows its beautiful interior exactly as it would have appeared when purchased new over 75 years ago.

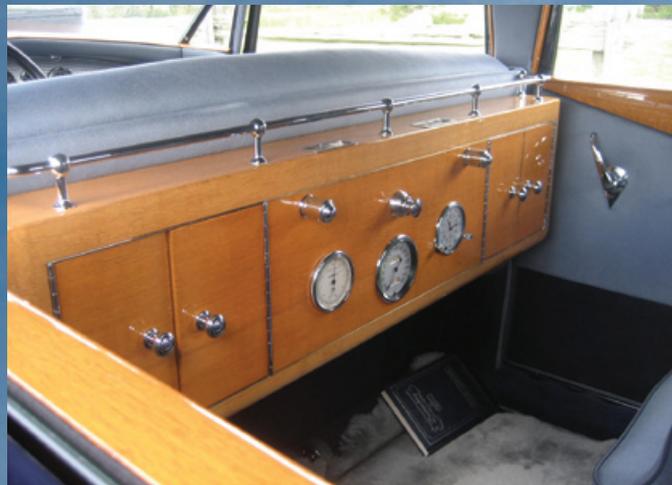
Murphy equipped this special Beverly Sedan with a full complement of instrumentation in the rear console, including speedometer, Jaeger chronometer and an altimeter, as well as a speaker and radio control head hidden behind the cabinet doors. As a final touch, the post-restoration photo here shows the plush sheep-skin rug and a Duesenberg owner's companion (manual).

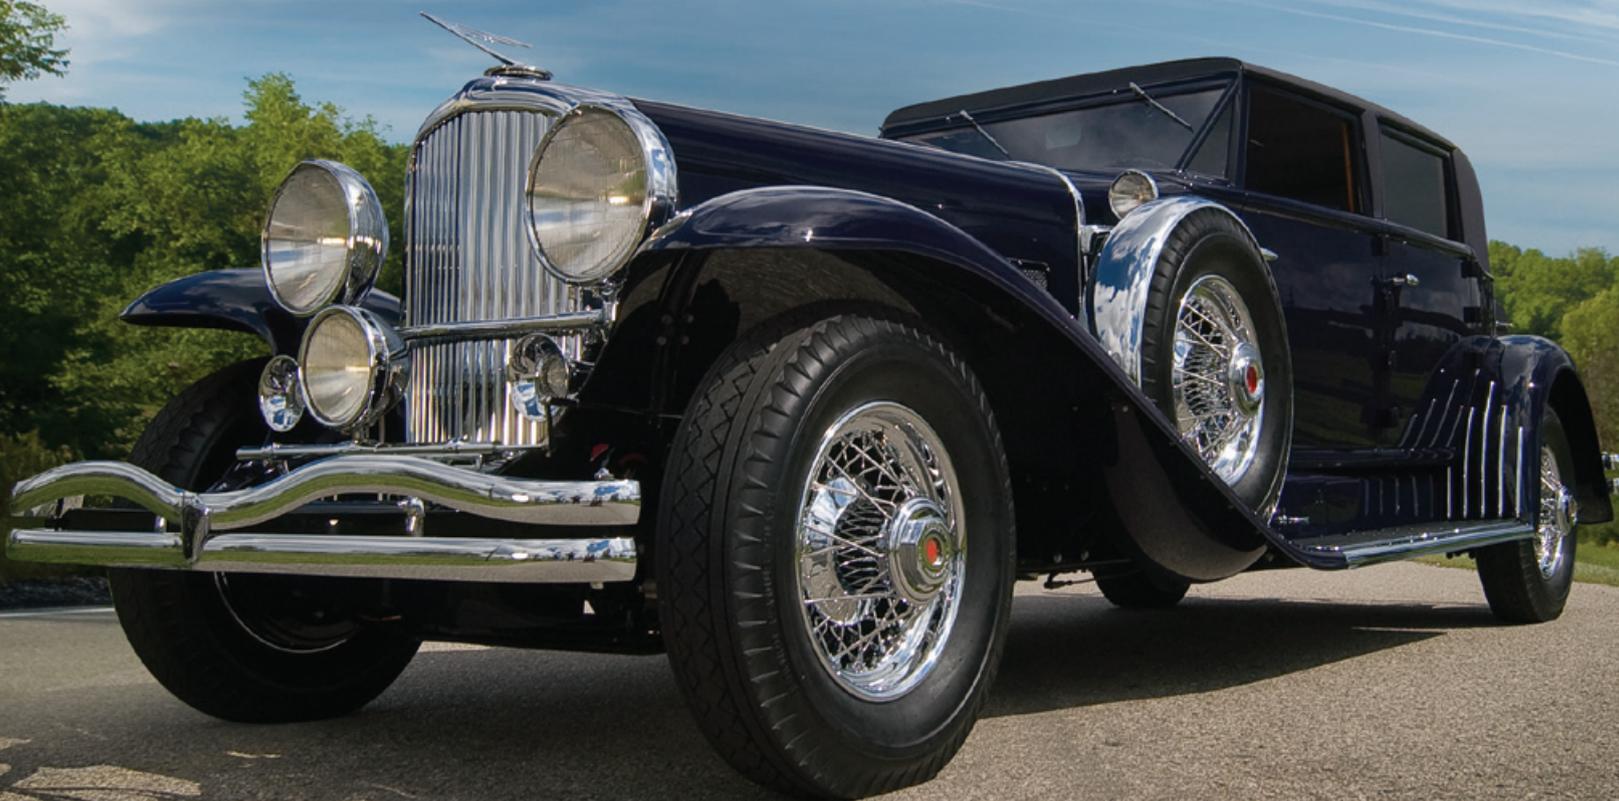
Elegant and imposing in its design, the Murphy Beverly Sedan is a perfect fit on Duesenberg's most powerful chassis. No detail was overlooked in this meticulous restoration, and the Cassinis never wavered in their commitment to bring SJ512 back to its original glory. Historically accurate, mechanically perfect, and visually breathtaking, the results speak for themselves.
